CASE STUDY

A fix for noisy drive systems

Gates describes a solution to a timing belt replacement issue that will reduce the number of comebacks for garages.

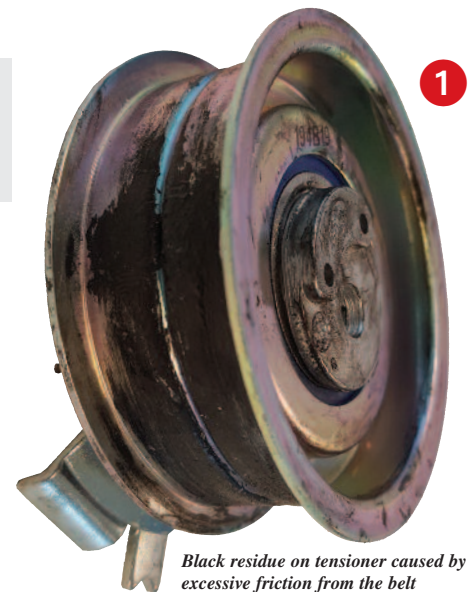
Examinations by Gates engineers have established that the clicking sound is being caused by the impact of the lever stop on the base plate stop. This is clearly caused by an installation error. Where drive belts have failed prematurely, inspection of the pulleys shows black residue marks left behind by the belt (**Fig 1**).

These black residue marks are evidence of excessive friction. When considered together, all of these facts point towards tensioners that have been set up incorrectly. A thorough analysis of similar incidents revealed that in each case, the problems were the result of common installation errors that were avoidable.

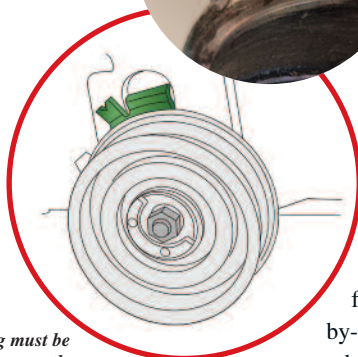
2

Note the lug on the tensioner highlighted in green (**Fig 2**). This is designed to fit into the centre of the appropriate slot on the engine block. It ensures that the tensioner is aligned correctly and that the SBDS can operate efficiently once the belt is installed.

The lug must be located correctly in the slot

1. Use the lug to position the tensioner in the precise position
2. Take no shortcuts with the tension setting cycle

With the lug located in the slot and the tensioner confirmed as correctly positioned, before your final tension adjustment, use the adjuster to turn the tensioner counter clockwise, until it stops (maximum tension). Use the adjuster to turn the tensioner back to the original position (minimum tension).

Repeat the cycle five times. That number five is important. Repeating the procedure five times enables the mechanism to adopt the optimum set-up position and ensures that the belt tension has been set correctly.
